PROPERTY & CONSTRUCTION CONSULTANTS

Homes for Haringey

**BROADWATER FARM ESTATE
STRUCTURAL ROBUSTNESS ASSESSMENT
4 & 6 STOREY BLOCKS**

April 2018

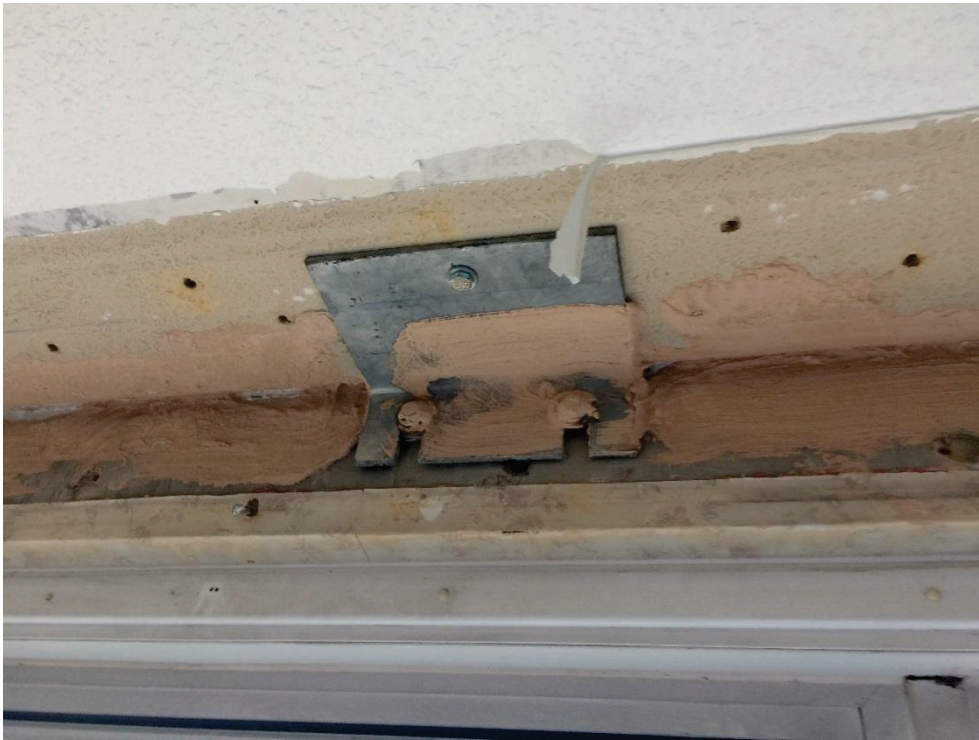
On site the remedial bolting of the non-structural cladding panels back to the slab were observed in the majority of the flats. The angle is hidden behind a fire-stopping coving so is only observed if this is removed during the ‘soft strip’ works, hence why it was not seen in every flat. However, in every instance that the coving was removed this angle detail was revealed. As the coving is a fire-stopping measure, and the angle fixing is not implicit in the assessment for disproportionate collapse, the coving was not removed unless required for other opening up works to be carried out.

The fixings found consisted of 200mm long 140x75x5 steel angles with a single resin fixing into the underside of the floor slab and two resin fixings in vertically slotted holes into the non-loadbearing cladding panels, see Figure 3. These angles were located approximately midway along the external walls in each room.

Figure 3 – Hawkinge: Remedial steel angle bolted to non-loadbearing cladding panel to reduce excessive movement

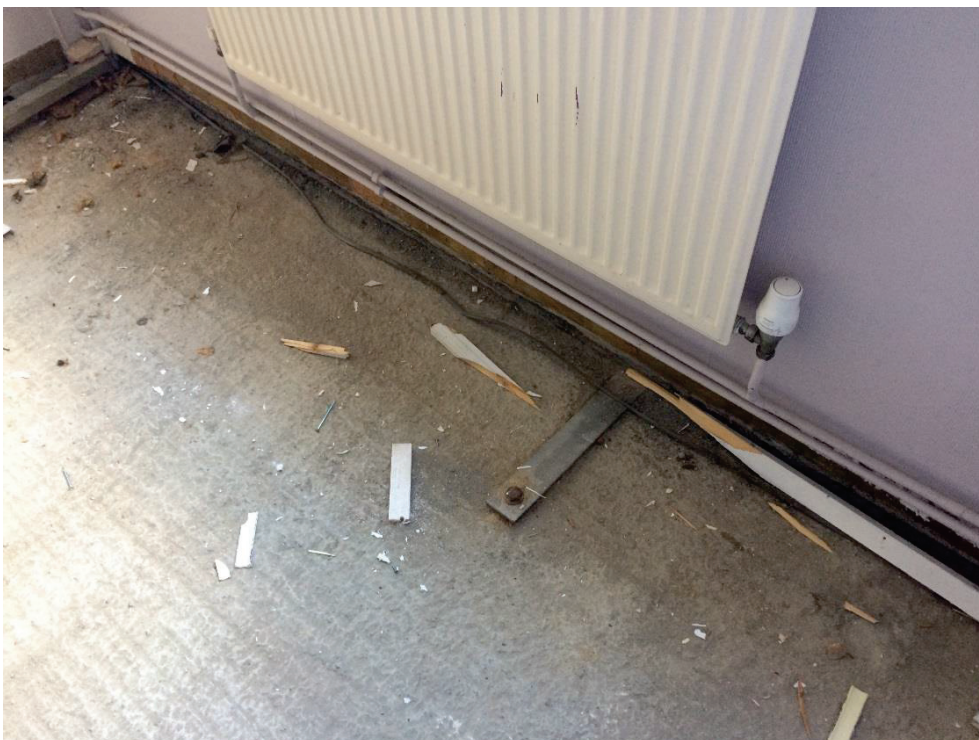
Another method for fixing back the external non-loadbearing wall, thought to be an original detail, was observed in the form of a steel strap anchored with a single bolt into the top of the floor slab, see Figure 4. These steel straps were also located approximately midway along the base of the external walls in each room.

Figure 4 – Hawkinge: Strap tying base of external wall panel back to the floor slab

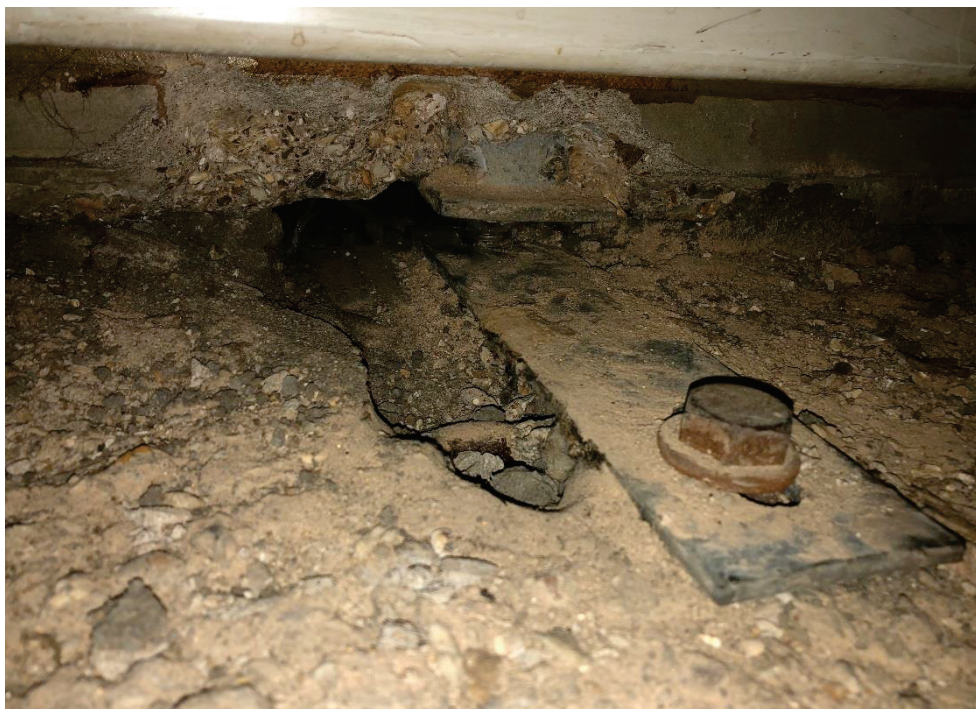
This steel restraint strap extends passed the end of the floor slab, running under the non-loadbearing external wall panels. The strap is tied to the wall panel by a 25mm diameter threaded bar protruding up from the wall panel below, passing through a hole in the steel strap and up into a steel 'top hat' threaded socket cast into the external wall, see Figure 5.

Figure 5 – Kenley: Threaded bar protruding from wall panel below, through hole in the strap, into a steel 'top hat' threaded socket cast into wall panel.

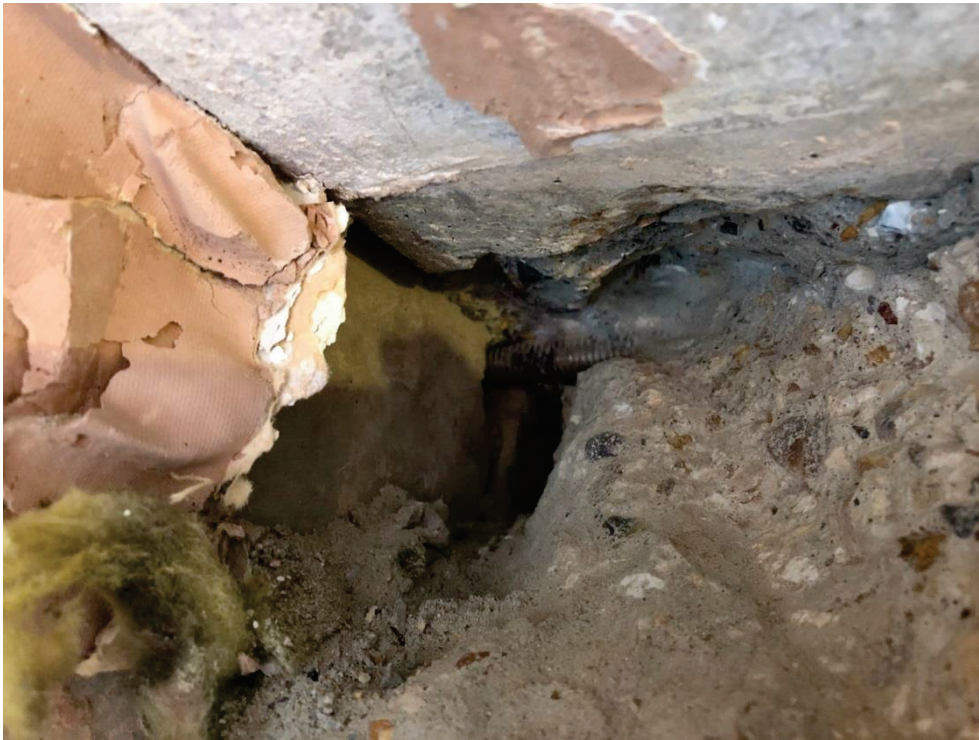
It is believed that an additional fixing tying the non-loadbearing external wall back to the main structure exists within the cross wall insitu joint, and was part of the original construction of the block. BRE Report 63 shows this detail, see Figure 6, which was confirmed by the opening up works to be present in Flat 42 Kenley, see Figure 7. Being of similar construction it is, therefore, assumed that this detail is also present in all blocks.

Figure 7 – Flat 42 Kenley - Threaded bar found within insitu cross wall joint tying the non-loadbearing cladding panel back to the main structure

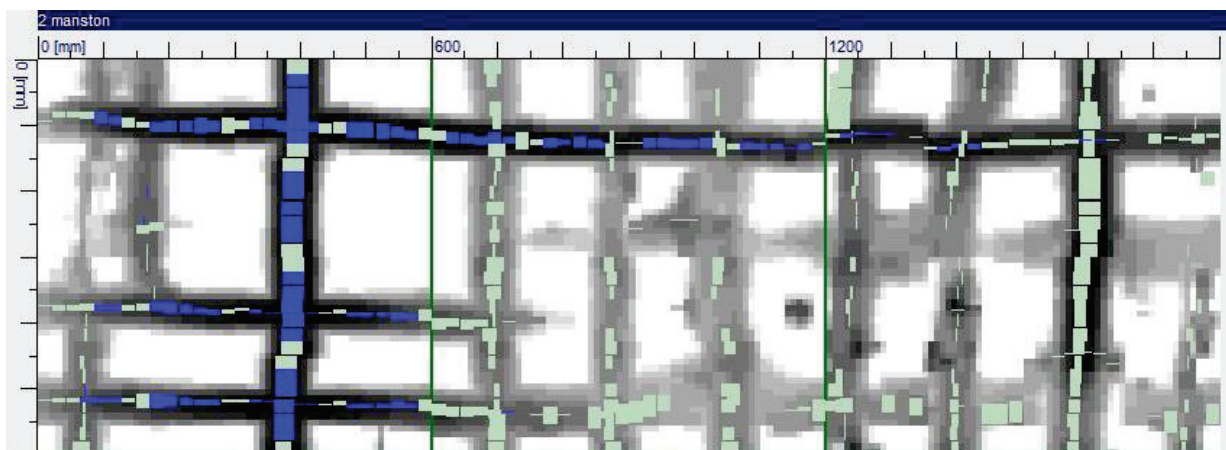
Figure 13 – Example of Three Wall Scans taken in Flat 2 Manston. The scans clearly show small diameter bars at regular 150mm c/c with two distinctively larger diameter link bars at approximately 1200mm centres. Two clear lateral bars are shown to extend the full width of the three scans, whereas the middle lateral bar appears to only be present in the first scan. It should also be noted the difference in clarity between the link bar in scan 1 compared to scan 3. This was a common occurrence throughout the scanning with some link bars being harder to identify.

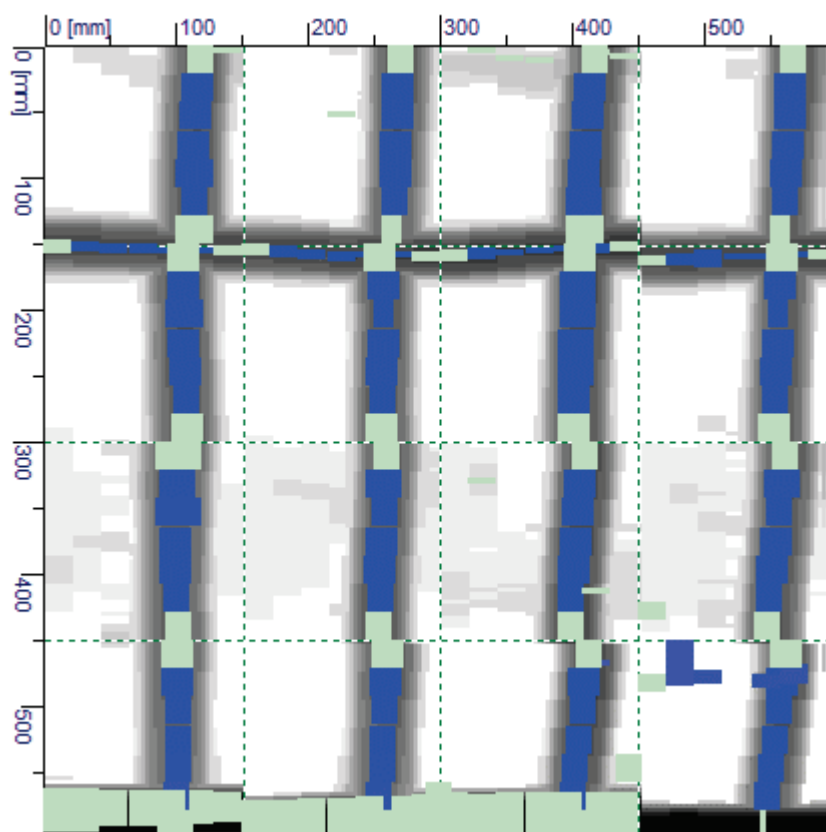
Figure 14 – Example of Ceiling Scan Data taken in Flat 2 Manston. Scan shows bars at close regular centres at the base of the slab.

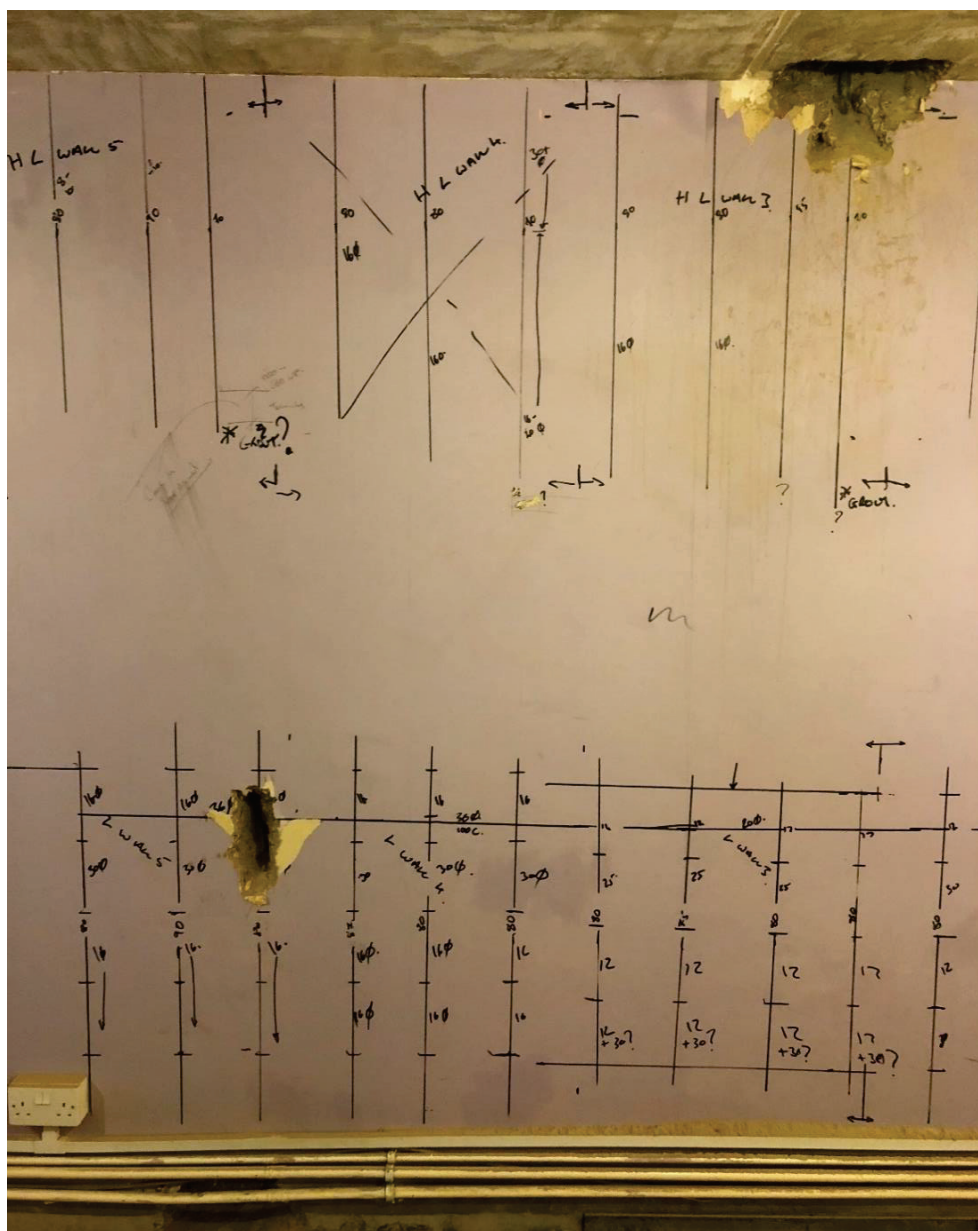
Figure 15 – Wall of Flat 2 Manston marked-up with the results from the two scans. The information obtained then used to identify areas for further investigation using intrusive methods.

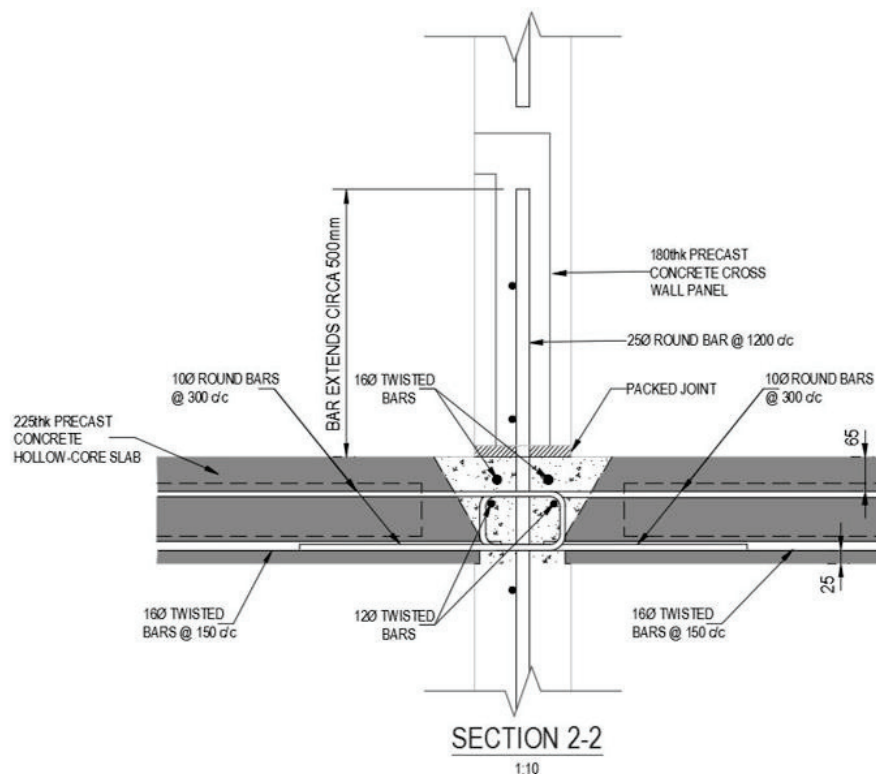
Generally, the construction comprised of 8" thick hollow core slabs spanning between 7" centrally reinforced pre-cast cross walls with vertical link bars at approximately 4' centres. The span direction was noted to change for the last span to each end of the block and the slabs span from the corridor to the flank wall. The flank walls are a 6" reinforced concrete panel with a single layer of reinforcement toward the rear of the panel, a corbel supports the precast concrete plank just below floor level.

Figure 16 – Example of insitu joint between Cross Walls and Floor Slabs

The vertical tie in the cross wall joints consisted of 25mm bars at 4' centres cast into the top of each panel and dry packed into the bottom of the panel above. The investigative works have also shown that these bars are not continuous in the wall panels. The bars extend circa 500mm up into a grout pocket cast into the bottom of the cross wall panels. Another bar is then cast into the panel above the grout pocket. This connection method is not sufficient to provide an effective vertical tie. In the event of a failure of a cross wall, the floor above which would have originally been taking bearing on the failed wall, would be reliant on hanging from the vertical bars protruding down from the wall above. These plain round bars are grouted into the walls and would offer little tensile resistance due to the minimal bond a smooth bar achieves. A pull-out failure of the bars would therefore be likely, causing the floor to fall away from the wall above.

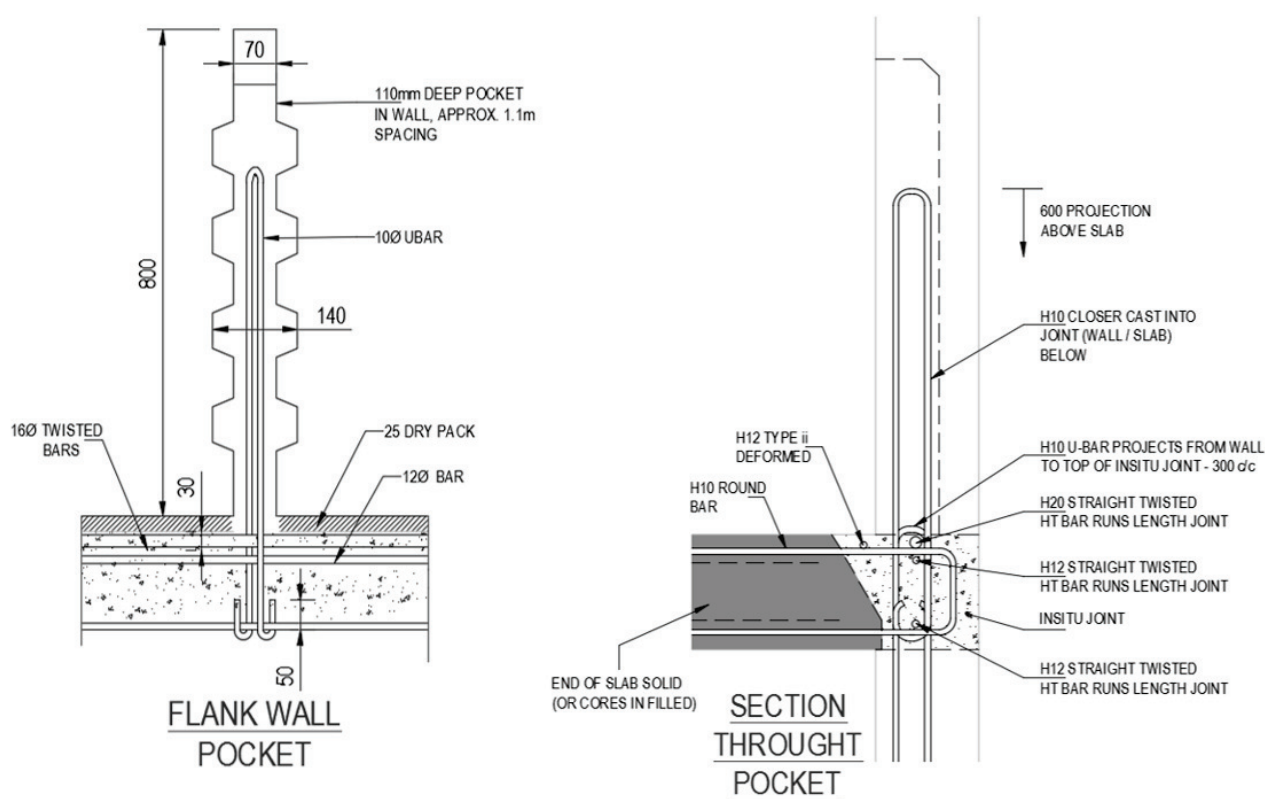
However, the investigative works carried out in the 4-storey wings showed that the cross wall panels are unreinforced and an inherent weakness was found around the formed pockets in the flank wall

Generally, the construction comprised of 8" thick hollow core slabs spanning between 7" pre-cast cross walls that were found to be largely unreinforced. The flank walls are a 6" reinforced concrete panel with a single layer of reinforcement toward the rear of the panel, a corbel supports the precast concrete plank just below floor level.

Figure 17 – Example of insitu joint between Flank Walls and Floor Slab

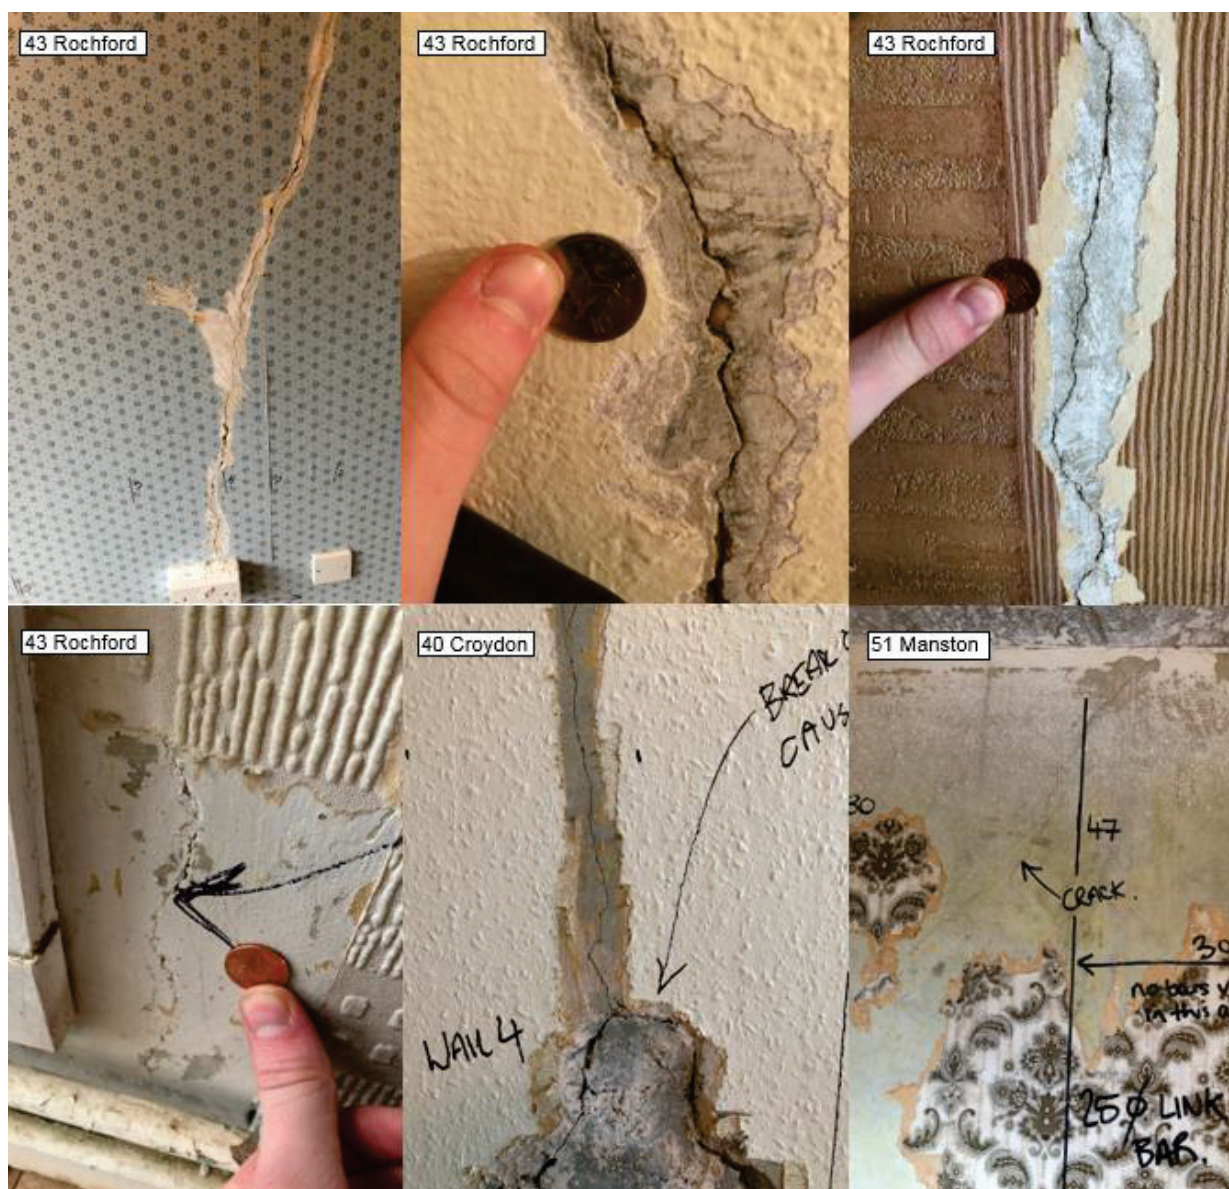
Throughout the investigation cracks were found to be a common occurrence in the loadbearing wall panels. The majority of cracks were vertical cracks running the entire height of the wall, and all the way through the thickness of the panel. There are a number of likely causes for the cracking within the panel which are thermal, shrinkage, poor curing or construction related damage. The cracks observed are not thought to affect the load bearing adequacy of the structure.

Figure 21 – Examples of cracking in loadbearing wall panels in various flats across Broadwater Farm Estate
