PROPERTY & CONSTRUCTION CONSULTANTS

Homes for Haringey

**BROADWATER FARM ESTATE
STRUCTURAL ROBUSTNESS ASSESSMENT
4 & 6 STOREY BLOCKS**

April 2018

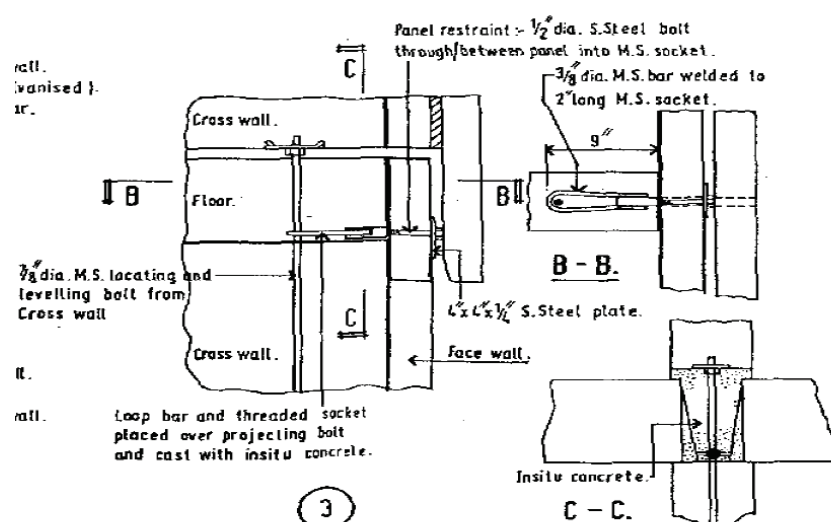
It is believed that an additional fixing tying the non-loadbearing external wall back to the main structure exists within the cross wall insitu joint, and was part of the original construction of the block. BRE Report 63 shows this detail, see Figure 6, which was confirmed by the opening up works to be present in Flat 42 Kenley, see Figure 7. Being of similar construction it is, therefore, assumed that this detail is also present in all blocks.

Figure 6 – Extract from BRE Report 63. Non-loadbearing cladding panel connection details. (Department of the Environment, 1985)

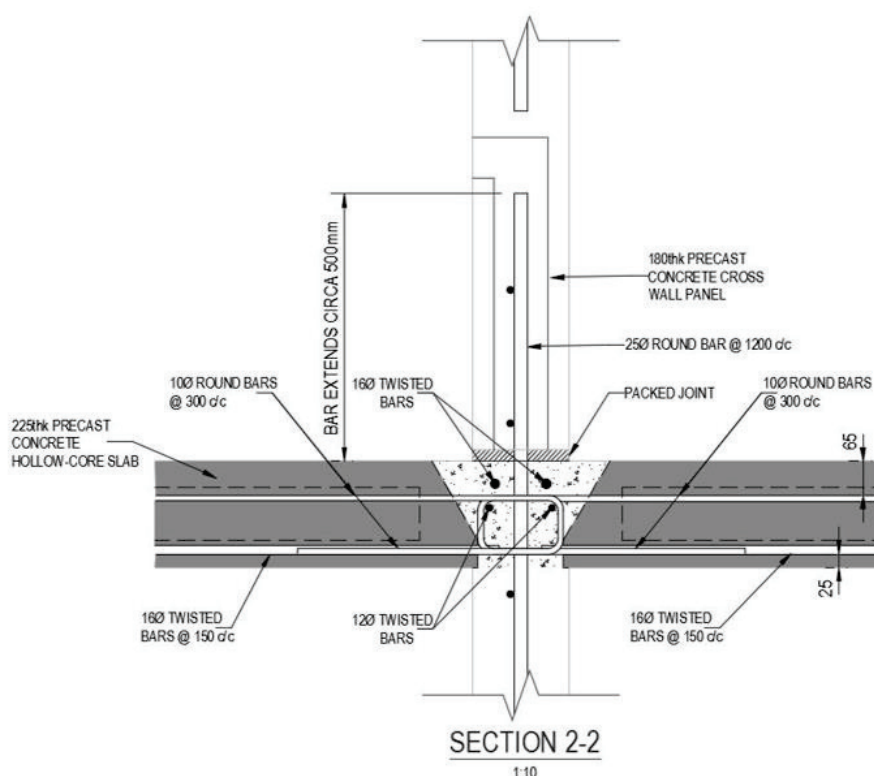
The joints between the loadbearing elements in the 6-storey blocks were found to possess an effective horizontal tie. However, the vertical tie in the joints was found to be insufficient. Therefore, the connections in these blocks do not pass LPS Criterion 1.

Figure 9 – Example of insitu joint between precast concrete units (Cross Wall to Floor Slab)

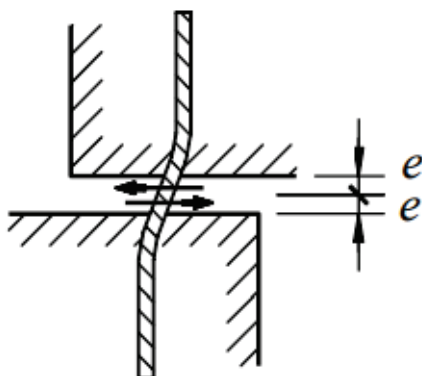
In the cross walls the likely failure mechanism was identified as local shear splitting failure around the 25mm link bars as these bars are the only reinforcement to extend into the joint. Diagrams of this failure can be seen in the extracts from fib Bulletin 43 in Figure 18 and Figure 19.

Figure 18 – Shear transfer by dowel action with double fixation (fib, 2008)

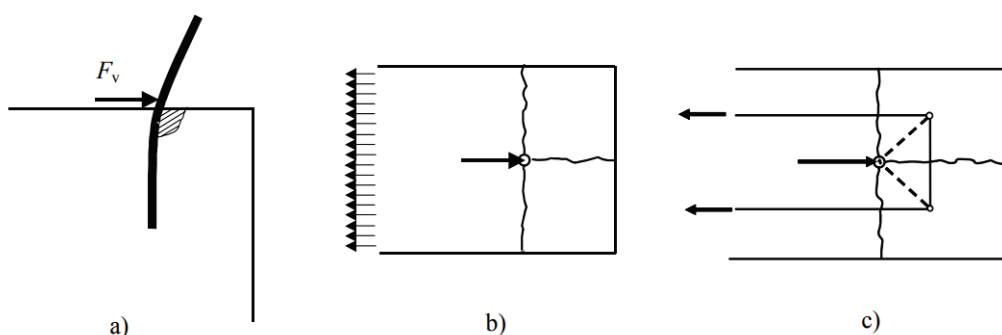
Figure 19 – Splitting effects around dowel pin loaded in shear, a) shear force acting on dowel bar indicating area of concrete under dowel subject to high stress concentration, b) potential planes of cracking, c) strut and tie model for design of splitting reinforcement – no splitting reinforcement found within wall panels.
